Appendix E. Other Supporting Information

Aquatic Resources Delineation
Lower Bear River Watershed Project
Box Elder County, Utah

J·U·B ENGINEERS, INC.

May 2025

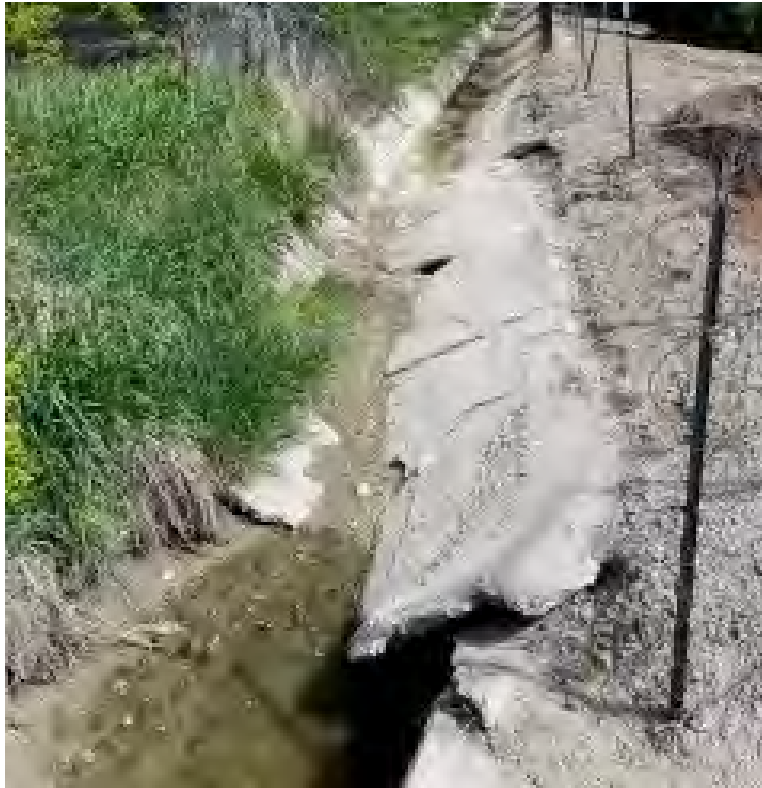
Sandy Spot
-
